Application of a surface-applied cathodic protection system on a light weight concrete bridge – Part I: Condition assessment, intervention options and trial investigations

Application of a surface-applied cathodic protection system on a light weight concrete bridge – Part II: Developments in time of the effectiveness by potential decay values and current densities

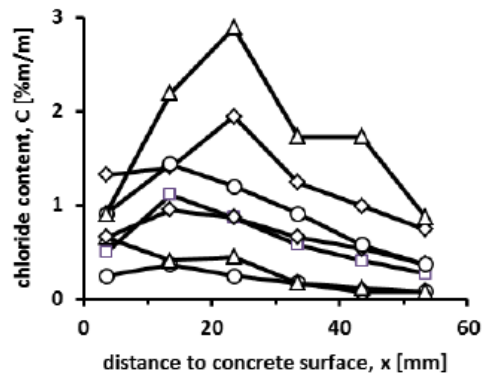
Figure 3. Variation in chloride profiles measured in the bridge soffit.

In addition, a limited number of powder samples were taken so as to quantify the chloride profiles and in particular the chloride content at the level of the reinforcing steel. The results obtained revealed the presence of chlorides with contents ranging from insignificant to values far in excess of 1% (by mass of cement). Figure 3 shows the significant variation in chloride profiles obtained on the bridge soffit (Boutz 2012a, Boutz 2012b, Boutz 2012c).

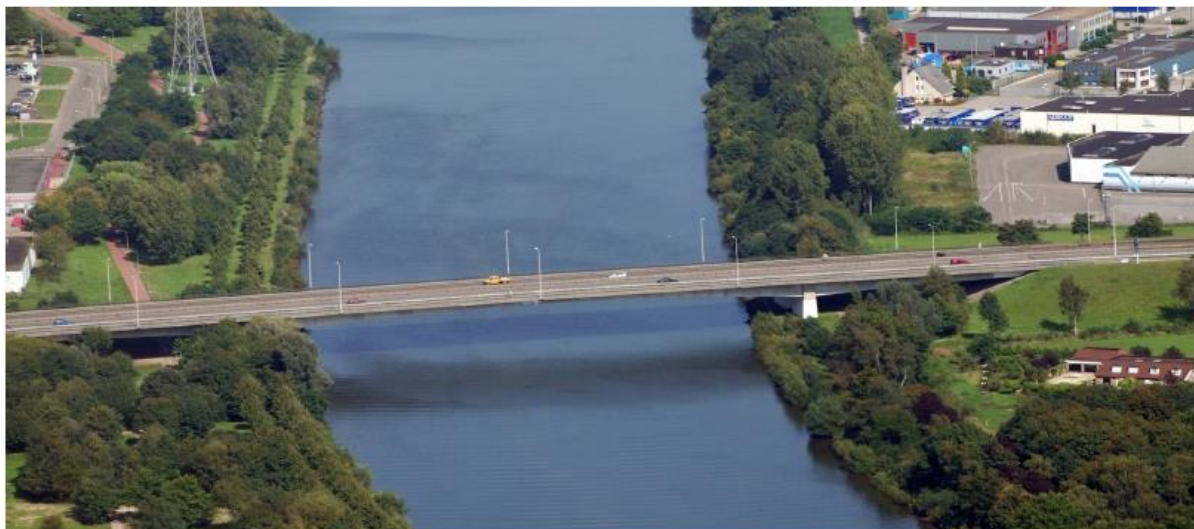
Figure 1. The Neerbossche Bridge over the Maas-Waal canal.

The object concerns the Neerbosche Bridge which spans the Maas-Waal canal at Nijmegen, The Netherlands (Figure 1). The bridge is a post tensioned double box girder bridge from 1982, of which the structure above the canal is constructed with light-weight concrete (1650 kg/m^3). The in-situ cast concrete segments have a length of about 3.4 meters. For each box girder, the part of the bridge located between the piers comprises 33 segments of which the 2 segments above the piers are constructed with conventional normal weight concrete. So each box girder is comprised of 31 light-weight concrete segments above the canal. The soffit of the light-weight concrete sections of the southern box girder showed serious damage and consequently maintenance was required in the short term in view of structural safety as well as possible danger for the shipping underneath the bridge due to falling lumps of concrete.

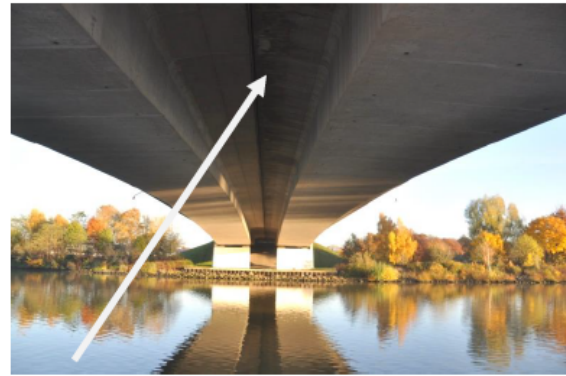
Figure 2. Location of the damaged cantilever (southern bridge).

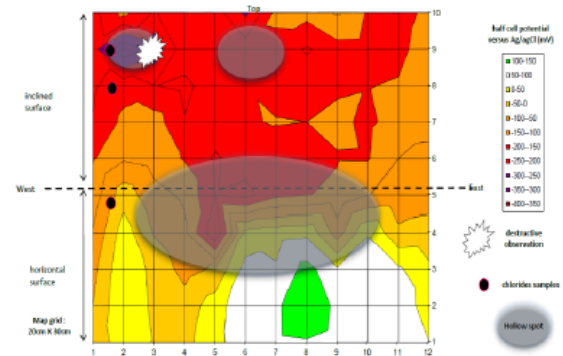
Figure 3. Corrosion potential measurements at the cantilever in the southern bridge. The grey areas denote hollow spots and the white flash a destructive investigation point.

The damage in the bridge was extensively investigated and reported in a preliminary phase and it was concluded that the damage was limited to the concrete surface at the soffit of the northern cantilever of the span of the southern bridge (Figure 2). Due to long-term leakage in the longitudinal joint between the northern and southern bridge, chlorides originating from the frequent application of de-icing salt during winter periods had penetrated into the concrete up to the level of the reinforcement and beyond. As a consequence, the mild steel reinforcement had started to corrode which eventually resulted in the development of significant tensile stresses in the concrete, leading to cracks, delaminations and spalling at multiple locations. The corrosion induced damage amounted to approximately 44 m^2 , which was about 22% of the total surface of the soffit. At other locations, the likelihood of corrosion was demonstrated by corrosion potential measurements which showed values down to -450 mV (Cu/CuSO_4) and -350 mV (Ag/AgCl ; see Figure 3).

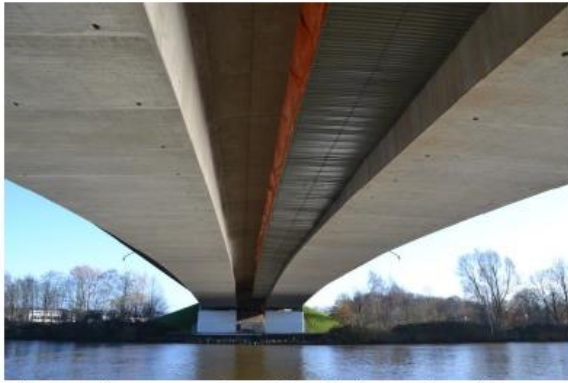
Figure 4. The access to the soffit at the damaged cantilever.

The canal underneath the bridge and the location of the cantilever in between the two box girders, at a height of approximately 10 meters above the water level, resulted in poor accessibility. In the past, a vessel with a scaffolding was used for the investigations on this part of the bridge, but due to the busy shipping on the canal and the instability of this kind of construction at a height of 10 meters it was not suitable for the extensive project. A new way for accessibility, developed in the USA, used cables across the canal to create a suspension bridge (Figure 4 & 5). This solution resulted in a good and safe access to the soffit, with no hindrance to the shipping and the possibility to create a closed environment above the water (preventing pollution of the water surface and enabling to work during the winter period).

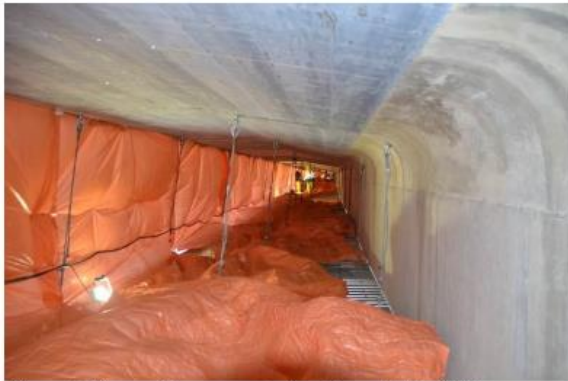
Figure 5. The workspace created underneath the bridge.

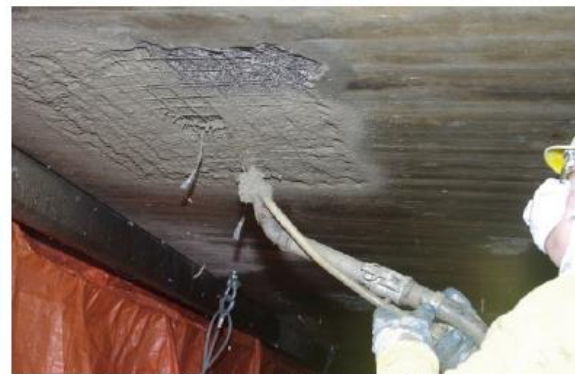
Figure 6. Repair of the damaged locations with shotcrete.

Before the mortar was applied, the surface at the repair location was treated by drilling in dowels (16 Hilti M8-100 per m^2). This is common practice in the application of shotcrete at pending surfaces in order to withstand the stresses due to shrinkage of the fresh mortar. Also, the light-weight concrete surface was, prior to the spraying of shotcrete, pre-moistened several times to prevent water being adsorbed from the applied fresh mortar. Finally, the shotcrete was applied in 2 successive layers, result-

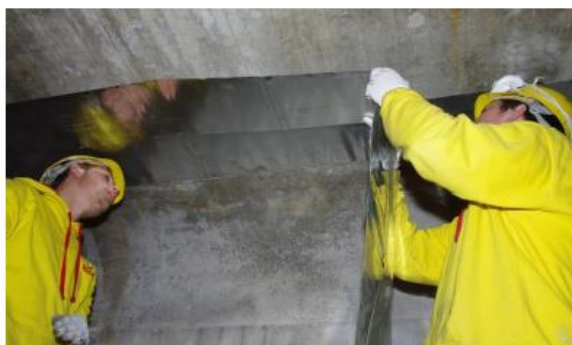
Figure 7. Application of the zinc anode in strips.

Based on corrosion potential measurements and the test results on the 2 bridge segments performed in 2013 it was concluded that the complete surface of the soffit should be covered with the zinc anodes (Figure 7). As there was no economic benefit in the application of ZLA in strips with a certain spacing, in order to save material costs, the complete concrete surface was covered with zinc strips using the standard width of 25 cm. The 'protection period' of the ZLA (i.e. material consumption over time) in relation to the cost for accessibility at the moment of an earlier replacement of anode material, made it clear that the application of extra ZLA would have a beneficial impact on the lifetime costs of the CP system.

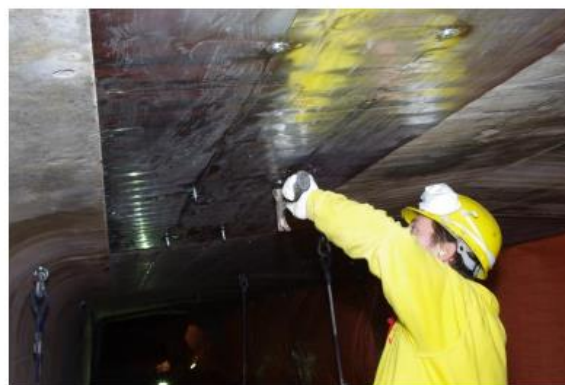
Figure 8. Connections at the overlaps of the zinc strips.

The 25 cm zinc strips were electrically connected by overlapping each strip slightly and shooting steel nails at a distance of one meter into the overlap (Figure 8). Connections to the steel reinforcement (the cathode) were made at 2 separate locations at each bridge segment. Finally the complete zinc surface, including the edges, was covered with a 2 mm thick layer of BASF 6100FX (a waterproof cement based coating) in order to prevent the zinc from direct contact with moisture due to condensation and the resulting atmospheric corrosion.

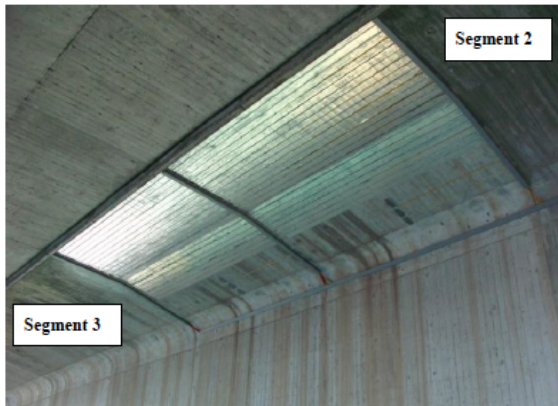
Figure 10. Test locations with the zinc anode material.

The CP system at the test segments was applied on the horizontal part of the cantilever and the adjacent 50 cm of the inclined segment (thus over a total width of approximately 2 meters). Each test segment was in this way covered with approximately 6,2 m² of ZLA (Figure 10).

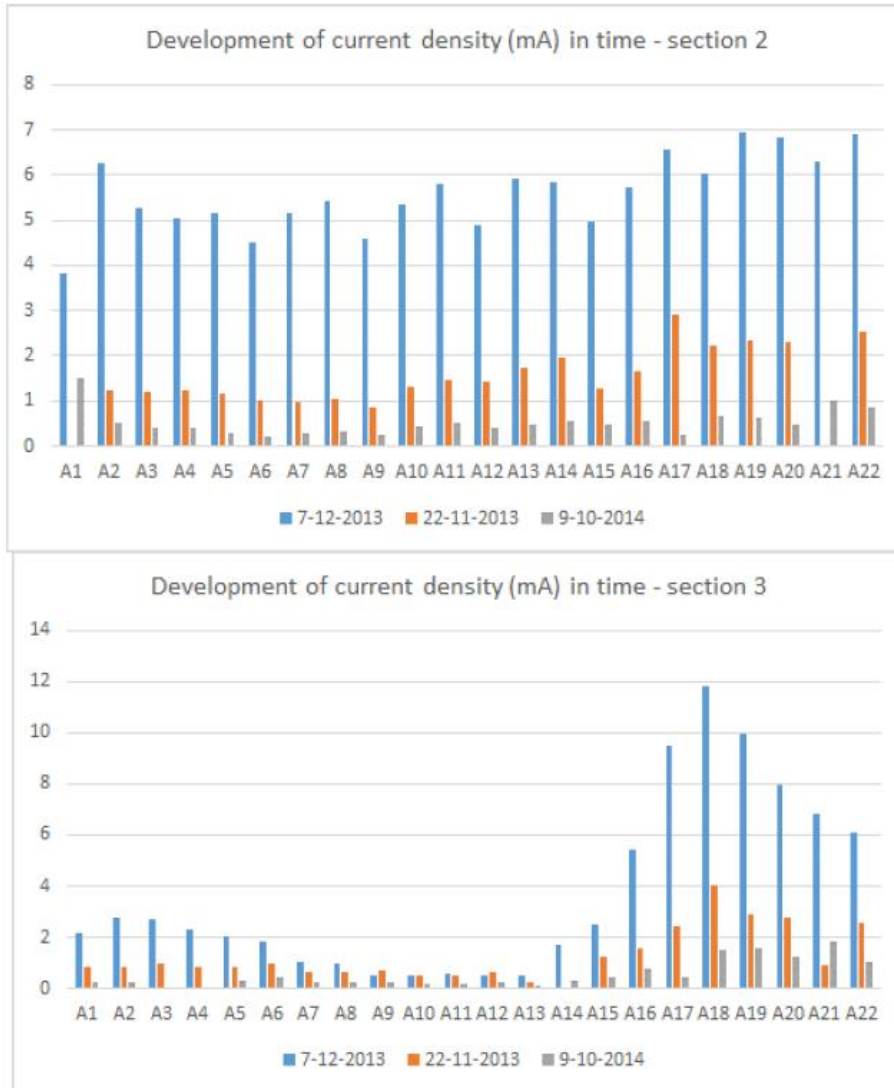
Figures 15 & 16. Development of the total current output in time for segments 2 and 3.

The measured current outputs strongly decreased over time (Figures 15 and 16). At the start in 2013 the total current output amounts to 28.6 mA (equal to 4.6 mA/m²_{anode} and approximately 7.7 mA/m²_{steel}) and 24.8 mA (equal to 4.0 mA/m²_{anode} and approximately 6.7 mA/m²_{steel}) for segment 2 and 3, respectively. After 14 months it was reduced to 5.4 mA (equal to 0.9 mA/m²_{anode} and approximately 1.5 mA/m²_{steel}; a reduction of 81%) and 6.8 mA (1.1 mA/m²_{anode} and approximately 1.8 mA/m²_{steel}; a reduction of 73%).

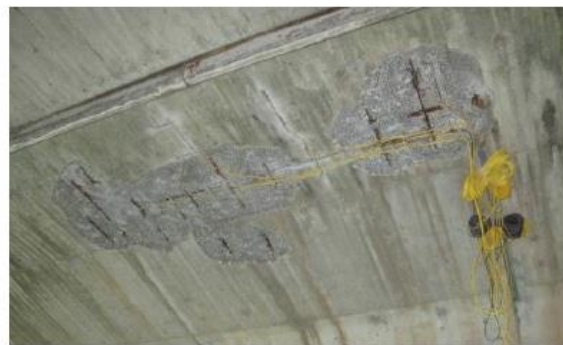
Figure 17. Repair locations and RE's in segment 3.

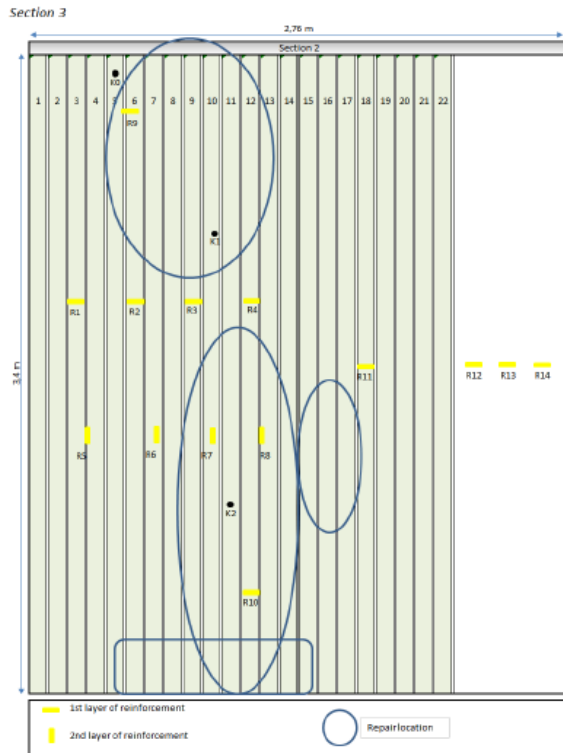
Figure 18. Anode strips, RE's and repair locations in segment 3.

The current outputs for each separate zinc foil (22 strips per segment) varied strongly in segment 3. The parts of segment 3 with small patched areas, between zinc strips A5 to A8 and A14 to A16, and the parts of this segment with larger patched areas, between zinc strips A9 to A13 (Figures 17 and 18), showed a lower current output compared to the non-patched areas. Specifically zinc strips A17 to A22 showed much higher current outputs.

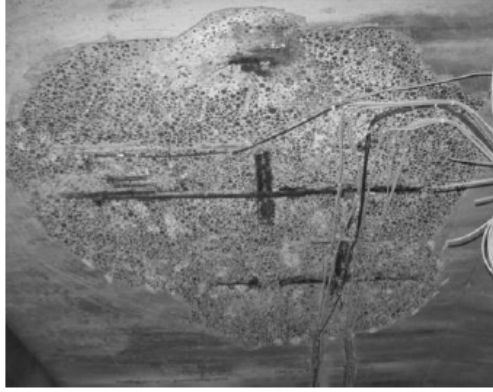
Figure 1. Spalled area of section 3.

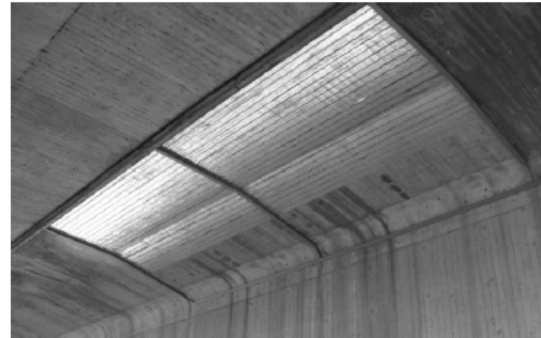
Figure 2. Zinc strips applied on section 2 and 3.

- 2 cathode contacts and on/off K_0 -switch for monitoring purposes ;
- 22 zinc layer anode strips, width 8 cm, with a distance of 1cm between the each strip, anode surface area appr. 7 m^2 per section.
- 22 external anode contacts.

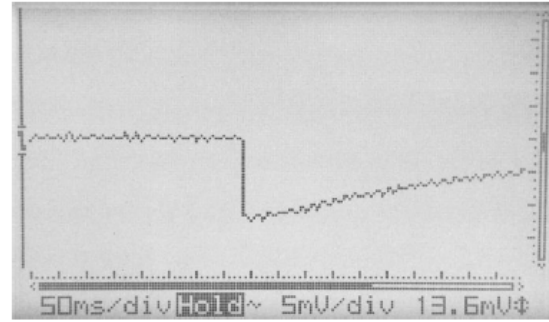
Figure 5. Oscillogram showing the "instant off" potential.

A total of 20 readings with the oscilloscope showed potential values between 13.6 and 29 mV.

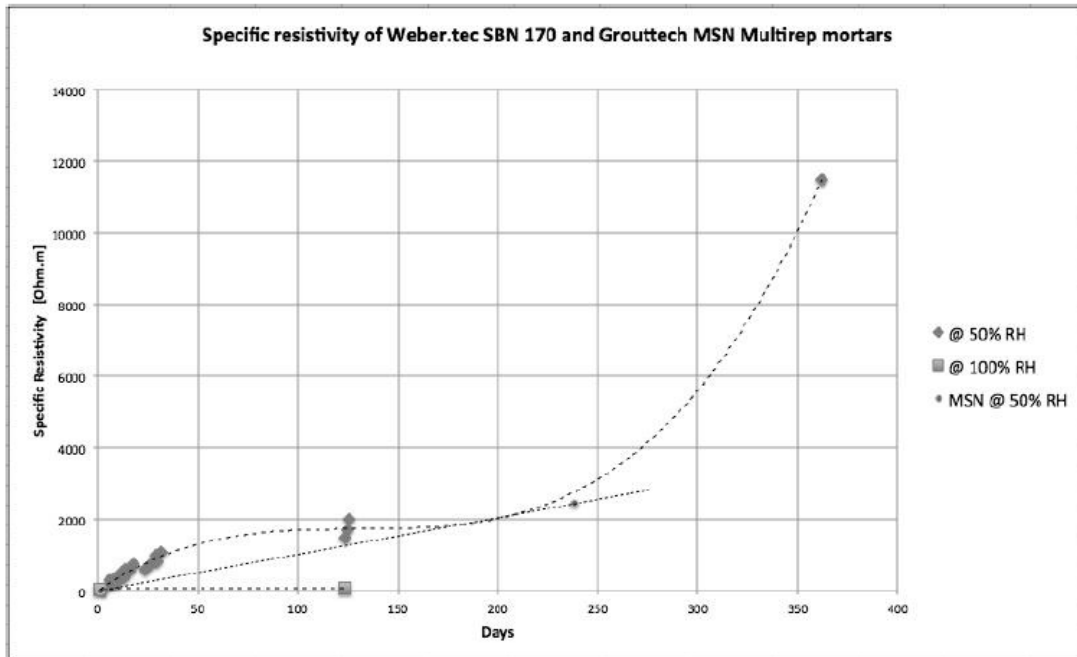
Figure 6. Progress of the resistivity over time of the 2 mortars used.

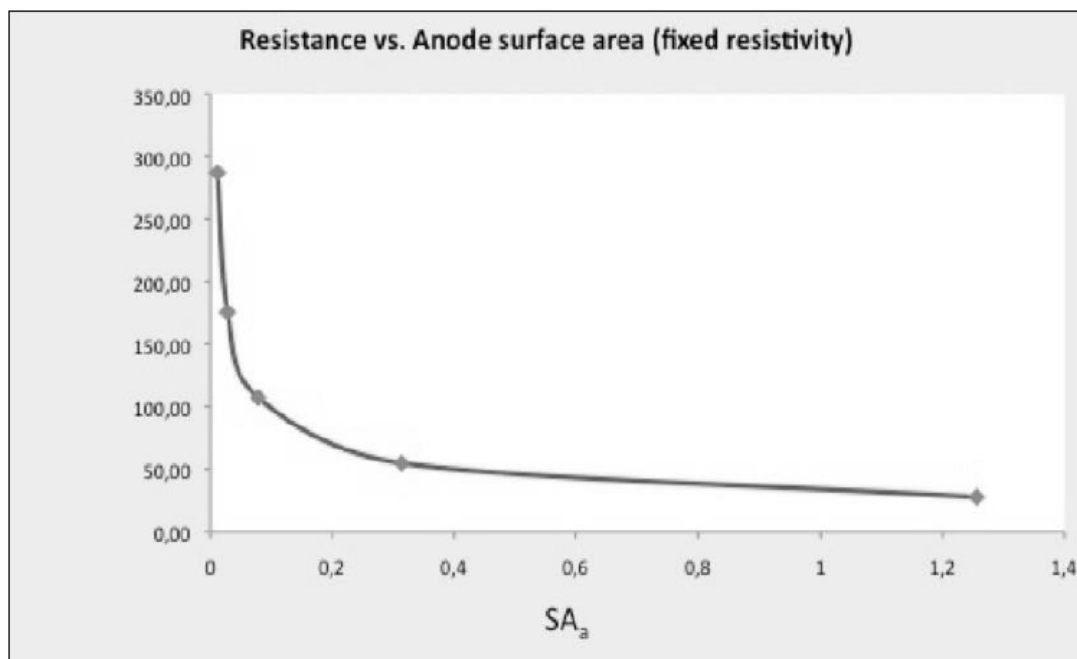
Figure 7. Graphic sketch of the theoretical relation between anode grounding resistance and anode surface area

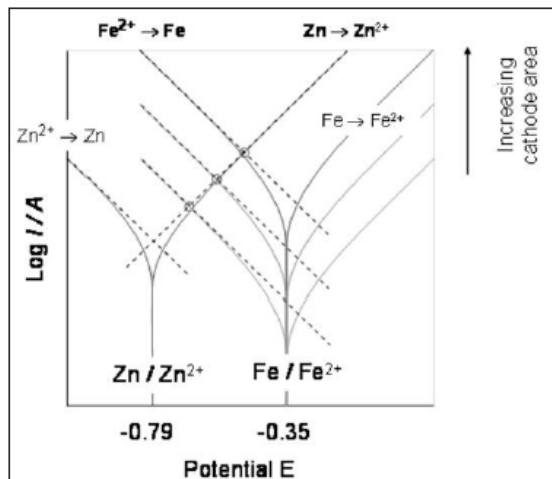
Figure 9. Theoretical E-log I polarisation curves of Fe vs. Zn by using total current output.
